**Flood Control Project Maintenance
Levee Inspections**
LMA District Cover Sheet
Spring 2017 Levee Inspection Results

City of Sacramento

Spring 2017 Levee Inspection Results

Waterway			Bank	Unit Miles
Unit No. 01 Sacramento River			Left	3.67
	Spring (March - May)	Summer (June - August)	(September - November) Fall	Winter (December - February)
Unit Maintenance Rating (Fall Only)				
Date of Inspection	3/29/2017 - 3/29/2017			
DWR Inspector	Zach Jojola			
Accompanied By	Dan Velez City of Sacramento

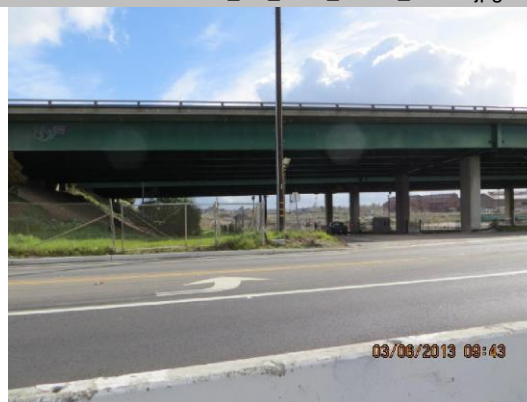
Photo 1 of 3 : UCIP_SP_2017_49955_33806.jpg

Comment Code					
Inspector Comment					
FS_ID:49955 DS_ID:21559 EP_NO: 14527 Repair Type: Non-Urgent Crossing Status: Found UCIP Comments: 7/19/2016 Paddle marker missing from WS--owner will need to work with CVFPB to determine if paddle marker on WS is necessary. (DWR UCIP - omagana)3/22/2016 Need to contact owner to determine condition of crossing and last inspection date. (DWR UCIP - omagana) FIELD_STRUCT_DESC: 12.75-inch steel gas line through levee (right bank), unable to confirm depth below the crown. Permit indicates the pipeline shall be buried with a minimum cover of 1 feet in the levee slopes and 2 feet through the levee crown. Line was directionally bored under the left bank levee and low water channel at a minimum cover of 44 feet and 21 feet, respectively. Paddle marker located approximately 150 feet from levee crown on landside (LS). (Permit No. 14527, 1987 - Southern Pacific Pipelines, Inc.) [Additional Reference(s): DWR Levee Log, 1993] FS Date: 7/19/2016

View of levee crown at crossing--sign visible on landward side near freeway underpass.

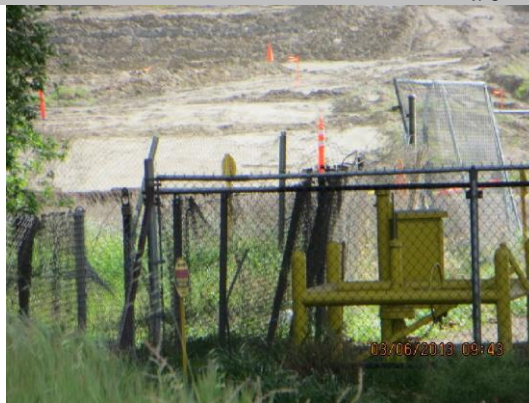
Photo 2 of 3 : UCIP_SP_2017_49955_33805.jpg

LM Start	0.06	Rating **	M	Issue No.	102 (cont)
LM End	0.06	Issue Type +	En	Location *	N/A

View of multiple markers indicating gas alignment.

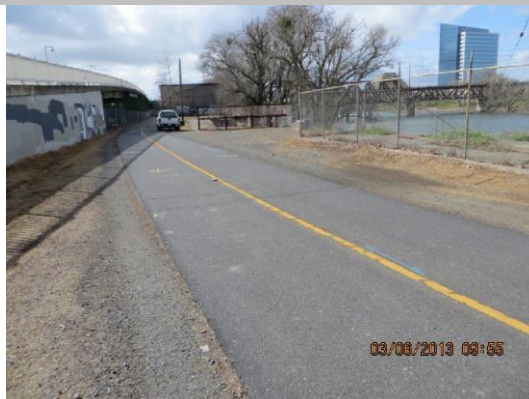
Photo 2 of 2 : UCIP_SP_2017_41415_72623.jpg

LM Start	0.14	Rating **	M	Issue No.	104 (cont)
LM End	0.14	Issue Type +	En	Location *	WS

Overview of levee crown looking downstream.

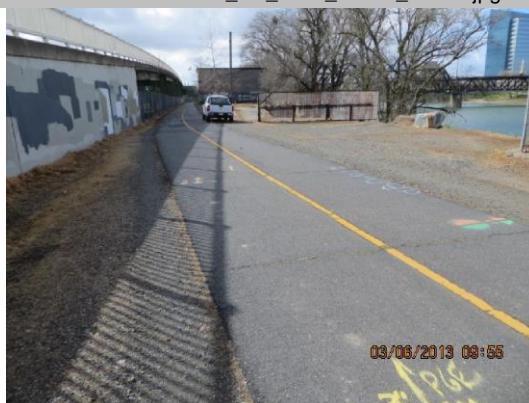
Photo 1 of 3 : UCIP_SP_2017_49956_72627.jpg

LM Start	0.15	Rating **	U	Issue No.	105
LM End	0.15	Issue Type +	En	Location *	WS
Category	Supplemental			GPS Latitude/Longitude	
				Start	End
Item	DWR UCIP Field Study			38.588636 °	38.588636 °
				-121.504860 °	-121.504860 °
DWR ID					
Comment Code					
Inspector Comment					
FS_ID:49956 DS_ID:24884 EP_NO: N/A Repair Type: Urgent Crossing Status: Indicator Found UCIP Comments: 07/19/2016 same as previous inspection. Need to contact owner to determine status of crossing. Unable to confirm alignment or depth through the levee crown. (DWR UCIP - omagana)10/17/2014 No markers found. Need to contact owner to determine status of crossing and to determine last inspection date. (DWR UCIP - omagana) FIELD_STRUCT_DESC: 3-inch steel gas line though levee at unknown depth. Underground alert service (USA) markings indicate this line is a PG&E line visible in 2013. FS Date: 7/19/2016

View of levee crown and alignment of PG&E line visible by yellow paint markings.

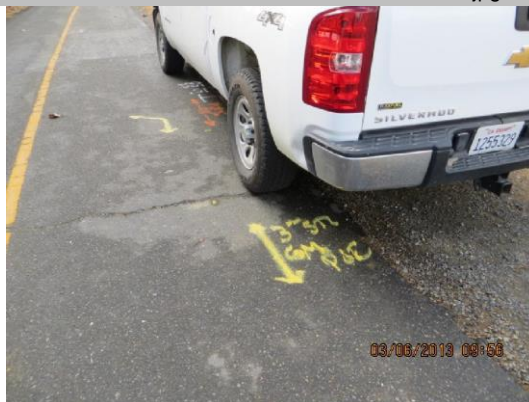
Photo 2 of 3 : UCIP_SP_2017_49956_72626.jpg

Underground Service Alert (USA) markings of PG&E line through levee, Photo 1 of 2.

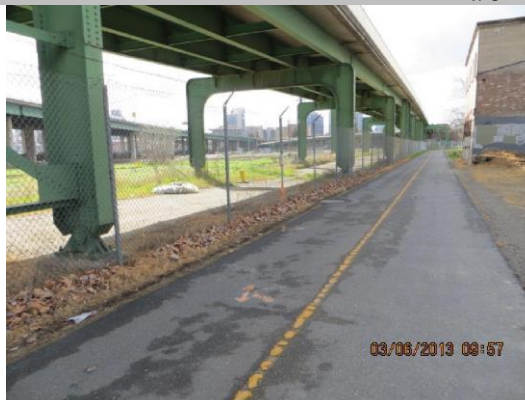
Photo 2 of 2 : UCIP_SP_2017_41416_72628.jpg

LM Start	0.16	Rating **	M	Issue No.	106 (cont)	
LM End	0.16	Issue Type +	En	Location *	WS	
Category	Supplemental			GPS Latitude/Longitude		
				Start	End	
Item	DWR UCIP Field Study			38.588500 °	38.588500 °	
				-121.504856 °	-121.504856 °	
DWR ID						
Comment Code						
Inspector Comment						
FS_ID:41416						
DS_ID:24885						
EP_NO: N/A						
Repair Type: Non-Urgent						
Crossing Status: Indicator Found						
UCIP Comments: No markers visible as per Title 23. Recommend having utility owner coordinate with Central Valley Flood Protection Board (CVFPB).						
FIELD_STRUCT_DESC: ATT communication line through levee at unknown depth.						
FS Date: 3/6/2013

Alignment of communication line through levee, Photo 2 of 2.

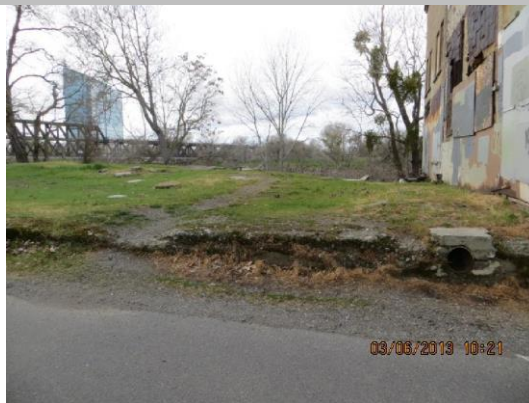
Photo 2 of 3 : UCIP_SP_2017_40848_72632.jpg

View of levee crown at crossing.

LM Start	0.22	Rating **	M	Issue No.	108 (cont)
LM End	0.22	Issue Type +	En	Location *	WS

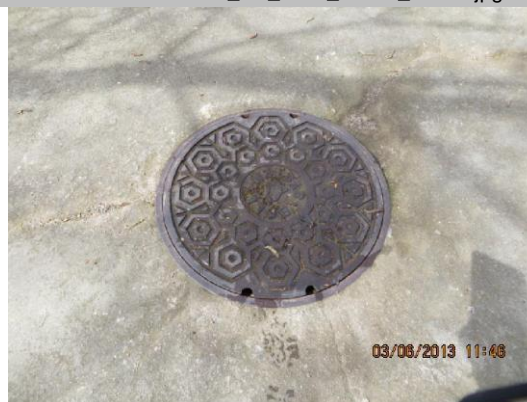
Photo 1 of 3 : UCIP_SP_2017_41417_72642.jpg

LM Start	0.42	Rating **	M	Issue No.	113
LM End	0.42	Issue Type +	En	Location *	WS
Category	Supplemental			GPS Latitude/Longitude	
				Start	End
Item	DWR UCIP Field Study			38.584767 °	38.584767 °
				-121.505700 °	-121.505700 °
DWR ID					
Comment Code					
Inspector Comment					
FS_ID:41417					
DS_ID:24890					
EP_NO: N/A					
Repair Type: Non-Urgent					
Crossing Status: Indicator Found					
UCIP Comments: Need additional information about crossing--depth of pipe, owner, status, and permit.					
FIELD_STRUCT_DESC: Submarine cable from the bed of the Sacramento River through and along the natural west levee of the river at a depth of 2 feet to a point in the town of Broderick, opposite a point approximately 434 feet downstream from the "I" Street Bridge, Sacramento. (Permit No. 881, 1942)					
FS Date: 3/6/2013

PacBell manhole located on waterward side.

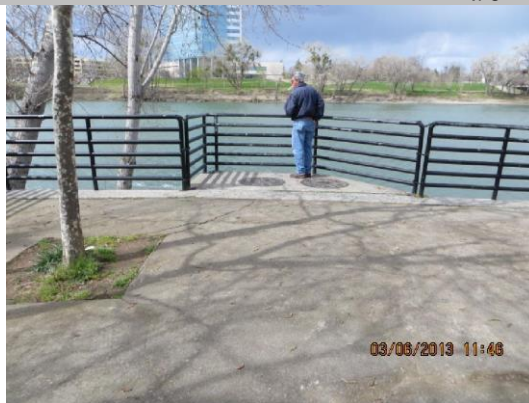
Photo 2 of 3 : UCIP_SP_2017_41417_72641.jpg

LM Start	0.42	Rating **	M	Issue No.	113 (cont)
LM End	0.42	Issue Type +	En	Location *	WS

Manholes located along levee--waterward side.

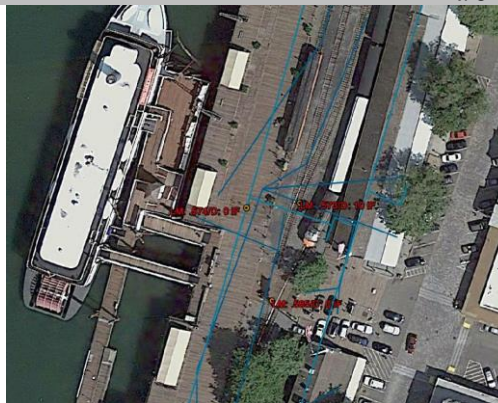
Photo 1 of 1 : UCIP_SP_2017_41419_72742.jpg

LM Start	0.57	Rating **	M	Issue No.	116
LM End	0.57	Issue Type +	En	Location *	WS
Category	Supplemental		GPS Latitude/Longitude		
			Start	End	
Item	DWR UCIP Field Study		38.582700 °	38.582700 °	
			-121.506266 °	-121.506266 °	
DWR ID					
Comment Code					
Inspector Comment					
FS_ID:41419 DS_ID:24895 EP_NO: N/A Repair Type: Non-Urgent Crossing Status: Indicator Found UCIP Comments: Need to confirm if crossing is still present. No signs visible during site visit. No photos available. FIELD_STRUCT_DESC: 10 inch line through levee. Record found in Sacramento County GIS records. FS Date: 3/6/2013

Approximate alignment provided by the City of Sacramento--unable to confirm crossing in field.

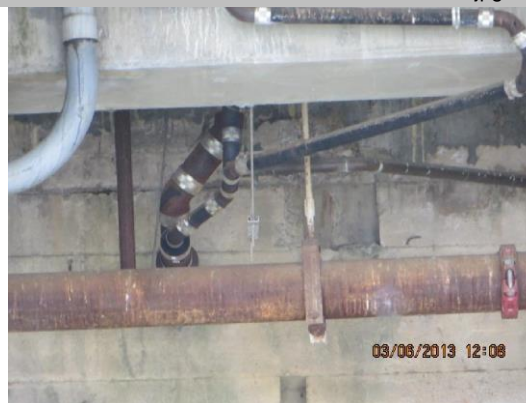
Photo 1 of 1 : UCIP_SP_2017_41260_72743.jpg

LM Start	0.57	Rating **	M	Issue No.	117
LM End	0.57	Issue Type +	En	Location *	WS
Category	Supplemental		GPS Latitude/Longitude		
			Start	End	
Item	DWR UCIP Field Study		38.582689 °	38.582689 °	
			-121.506419 °	-121.506419 °	
DWR ID					
Comment Code					
Inspector Comment					
FS_ID:41260 DS_ID:24896 EP_NO: N/A Repair Type: Non-Urgent Crossing Status: Indicator Found UCIP Comments: Unable to determine if crossing is active--need to contact owner to determine status and additional details of crossing. FIELD_STRUCT_DESC: Conduit group through floodwall. FS Date: 3/6/2013

Conduit through floodwall.

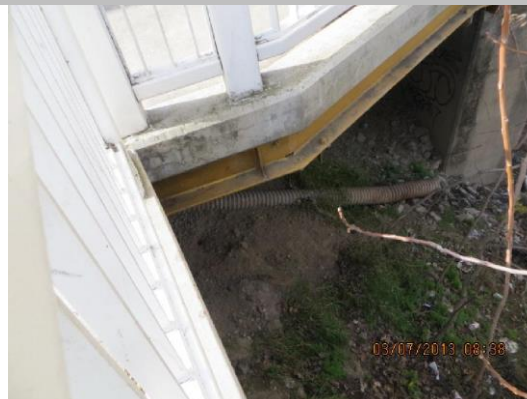
Photo 2 of 3 : UCIP_SP_2017_41421_72749.jpg

LM Start	0.74	Rating **	M	Issue No.	126 (cont)
LM End	0.74	Issue Type +	En	Location *	WS

Pipe visible on waterward side.

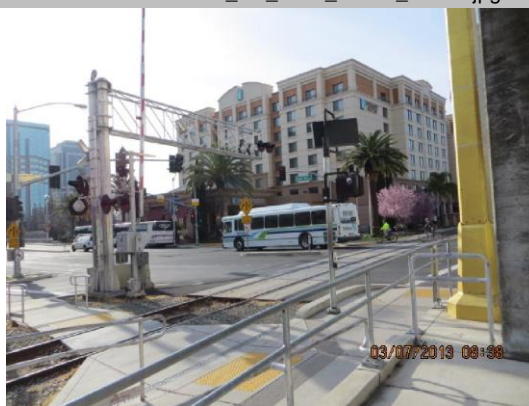
Photo 3 of 3 : UCIP_SP_2017_41421_72748.jpg

LM Start	0.74	Rating **	M	Issue No.	126 (cont)
LM End	0.74	Issue Type +	En	Location *	WS
Category	Supplemental			GPS Latitude/Longitude	
				Start	End
Item	DWR UCIP Field Study			38.580413 °	38.580413 °
				-121.507166 °	-121.507166 °
DWR ID					
Comment Code					
Inspector Comment					
FS_ID:41421 DS_ID:24905 EP_NO: N/A Repair Type: Non-Urgent Crossing Status: Indicator Found UCIP Comments: Need to contact owner to determine status and permit number for crossing. FIELD_STRUCT_DESC: Corrugated metal drainage pipe through floodwall visible on waterward side. FS Date: 3/6/2013

View of general area immediately downstream from crossing.

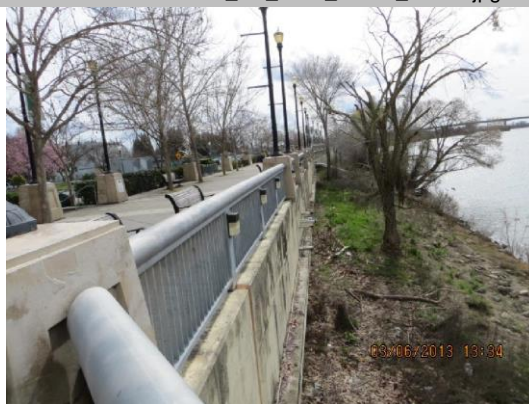
Photo 1 of 3 : UCIP_SP_2017_41422_72754.jpg

LM Start	0.81	Rating **	M	Issue No.	129
LM End	0.81	Issue Type +	En	Location *	WS
Category	Supplemental			GPS Latitude/Longitude	
				Start	End
Item	DWR UCIP Field Study			38.579353 °	38.579353 °
				-121.507560 °	-121.507560 °
DWR ID					
Comment Code					
Inspector Comment					
FS_ID:41422					
DS_ID:24908					
EP_NO: N/A					
Repair Type: Non-Urgent					
Crossing Status: Indicator Found					
UCIP Comments: Need to contact owner to determine status, purpose for lines, and permit number.					
FIELD_STRUCT_DESC: Cluster of conduits through floodwall visible from waterward side.					
FS Date: 3/6/2013

View of levee just downstream from crossings.

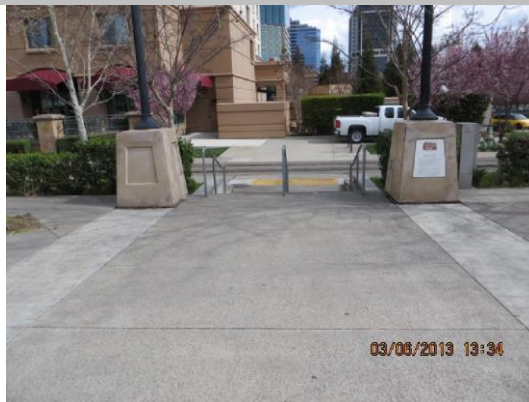
Photo 3 of 3 : UCIP_SP_2017_41422_72752.jpg

LM Start	0.81	Rating **	M	Issue No.	129 (cont)
LM End	0.81	Issue Type +	En	Location *	WS

View of landward side.

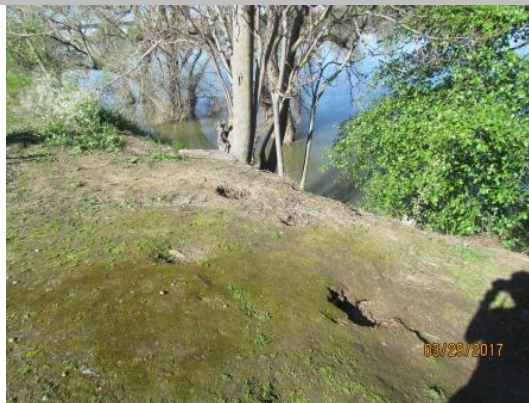
Photo 1 of 1 : SP_2017_NA0005_251_80_20170414_00139.jpg

LM Start	1.16	Rating **	M	Issue No.	80
LM End	1.16	Issue Type +	Ma	Location *	WS
Category	Earthen Levee			GPS Latitude/Longitude	
				Start	End
Item	Animal Control			38.574799 °	38.574799 °
				-121.510170 °	-121.510170 °
DWR ID	DWR_NA0005_01_s_2017_80				
Comment Code					
A3 : No rodents visible, but rodent burrows visible; need to backfill and compact or grout burrows.					
Inspector Comment

Multiple burrow holes on waterside levee slope. Spring 2017.

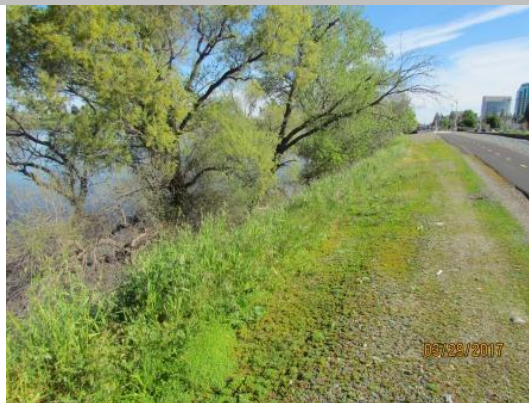
Photo 1 of 1 : SP_2017_NA0005_251_89_20170414_00141.jpg

LM Start	1.18	Rating **	M	Issue No.	89
LM End	1.70	Issue Type +	Ma	Location *	WS
Category	Earthen Levee			GPS Latitude/Longitude	
				Start	End
Item	Vegetation			38.574580 °	38.568512 °
				-121.510396 °	-121.516020 °
DWR ID	DWR_NA0005_01_s_2017_89				
Comment Code					
V1 : Control annual grass and weeds on the levee slopes and easements.					
Inspector Comment

Large grass blocking visibility on waterside levee slope. Spring 2017.

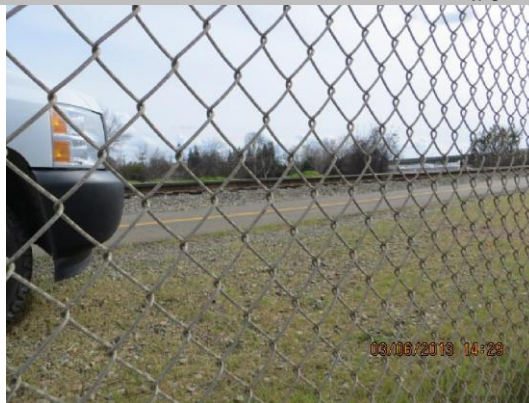
Photo 1 of 3 : UCIP_SP_2017_41425_34145.jpg

LM Start	1.24	Rating **	M	Issue No.	130 (cont)
LM End	1.24	Issue Type +	En	Location *	WS

View of railroad and bike path located on levee crown--wide levee.

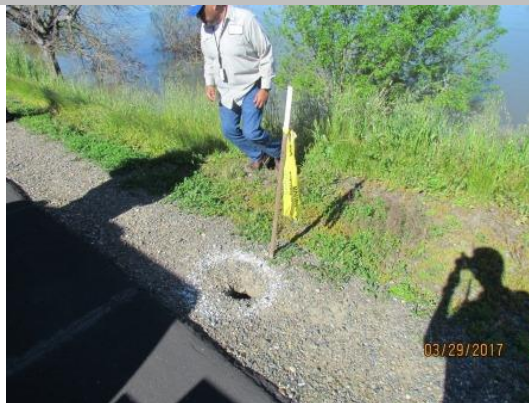
Photo 1 of 2 : SP_2017_NA0005_251_76_20170414_00145.jpg

LM Start	1.29	Rating **	M	Issue No.	76
LM End	1.29	Issue Type +	Ma	Location *	WS
Category	Earthen Levee			GPS Latitude/Longitude	
				Start	End
Item	Animal Control			38.573240 °	38.573240 °
				-121.511707 °	-121.511707 °
DWR ID	DWR_NA0005_01_s_2017_76				
Comment Code					
A3 : No rodents visible, but rodent burrows visible; need to backfill and compact or grout burrows.					
Inspector Comment

Rodent hole on waterside levee slope, looking towards Sacramento River. Spring 2017.

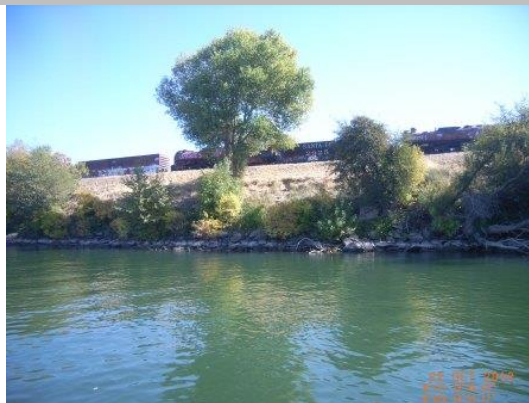
Photo 1 of 2 : SP_2017_NA0005_251_1_20170320_00001.jpg

LM Start	1.31	Rating **	M	Issue No.	1 (cont)
LM End	1.39	Issue Type +	Ma	Location *	WS

USACE 2013 Photo #1

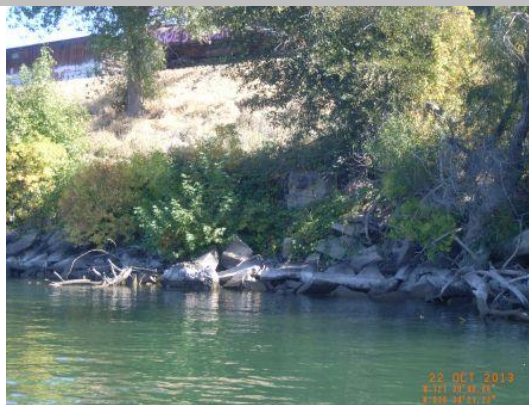
Photo 2 of 2 : SP_2017_NA0005_251_1_20170320_00002.jpg

USACE 2013 Photo #2

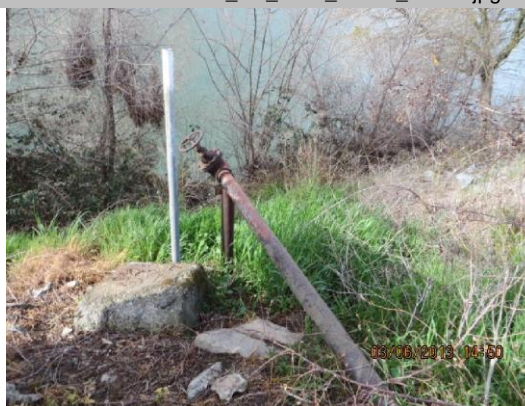
Photo 1 of 3 : UCIP_SP_2017_49957_34071.jpg

Comment Code					
Inspector Comment					
FS_ID:49957 DS_ID:21969 EP_NO: N/A Repair Type: Non-Urgent Crossing Status: Found UCIP Comments: 07/19/2016 Crossing has been re-classified from Urgent to Non-Urgent leak has been repaired. Need to coordinate with owner to determine alignment of crossing and depth through the levee. (DWR UCIP - omagana)10/17/2014 Subsidence visible on landward side--DWR inspector was notified during field visit. Dense vegetation limits the inspector's visibility to identify signs of pipe failure (leaks) along the waterward and landward slope. Recommend removing vegetation along pipe alignment to conduct proper inspection of structure and appurtenances. (DWR UCIP - omagana) FIELD_STRUCT_DESC: 2 of 3: 72-inch concrete sewer line through the levee at low elevation. Slide gate inside concrete well located on the waterside (WS) slope. Manhole located on landside (LS) berm. Multiple manholes are located on LS berm. [Additional Reference(s): DWR Levee Log, 1993] FS Date: 7/19/2016

View of 6 inch pipe and shut-off valve located on waterward slope.

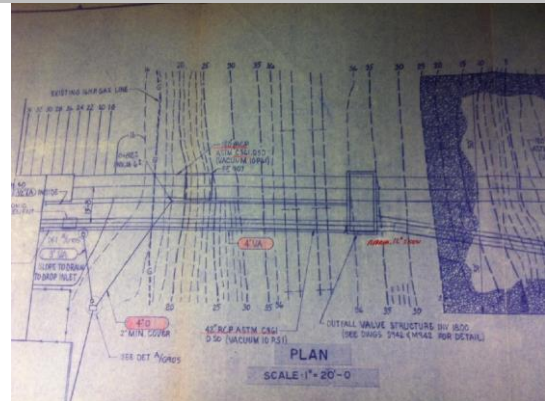
Photo 1 of 3 : UCIP_SP_2017_49778_34024.jpg

DWG showing 42-inch and 120-inch pipes through levee and connection to outfall valve structure.

Comment Code					
Inspector Comment					
FS_ID:49778 DS_ID:22483 EP_NO: 12196 Repair Type: Non-Urgent Crossing Status: Found UCIP Comments: Vault located on levee crown (bike path) and siphon breaker located on waterward shoulder. Coordinate with City of Sacramento to determine the condition of this crossing and last inspection. FIELD_STRUCT_DESC: [Pioneer Outfall] 1 of 2: 42-inch reinforced concrete water pipe through levee, approximately 10 feet below crown. Crossing is a wash water intake pipe used to clean out the larger pipe. Line extends approximately 145 feet from the intake to the outfall valve structure located on the waterside (WS) shoulder of the levee. Pipe is skewed approximately 12 degrees upstream. Water Intake structure has a screen located on the WS intake. WS slope is armored by rock slope protection. Rock slope protection perimeter exists at river intake. Stairway is located on the landside (LS). (42-inch pipe was installed under Permit No. 12196, 1981 - Sacramento Regional County Sanitation District; pipe was relined under Permit No. 16611, 1996 - City of Sacramento, Department of Utilities) FS Date: 3/6/2013

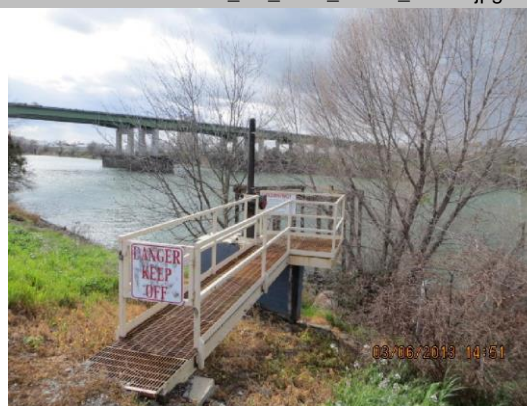
Photo 3 of 3 : UCIP_SP_2017_49778_34025.jpg

Walkway present on waterward shoulder.

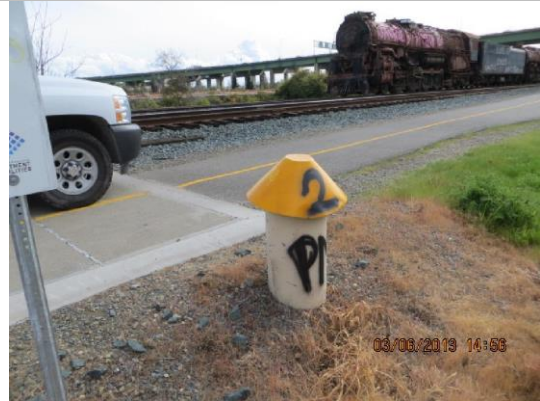
Photo 1 of 3 : UCIP_SP_2017_49958_34051.jpg

Comment Code					
Inspector Comment					
FS_ID:49958 DS_ID:21569 EP_NO: 12196 Repair Type: Non-Urgent Crossing Status: Found UCIP Comments: 7/19/2016 Leak was repaired. Leak was caused by failed gasket. Sink hole present on LS was pressure grouted. (DWR UCIP - omagana)10/17/2014 Check with City of Sacramento to determine last inspection and condition of crossing. Vegetation on waterward and landward slope makes it difficult to inspect and identify any potential leaks visible from surface. (DWR UCIP - omagana) FIELD_STRUCT_DESC: [Pioneer Outfall] 2 of 2: 120-inch reinforced concrete outfall pipe through the levee, 3 feet below the crown. Pipe extends approximately 117 feet from the discharge point to a reinforced concrete outfall valve structure located on the waterside (WS) shoulder. WS slope is armored by rock slope protection. Rock slope protection perimeter exists at outlet. (120-inch pipe installed under Permit No. 12196, 1977 - Sacramento Regional County Sanitation District) [Additional Reference(s): DWR Levee Log, 1993] FS Date: 7/19/2016

View of levee crown--outlet valve structure located along bike path and siphon breaker on waterward shoulder.

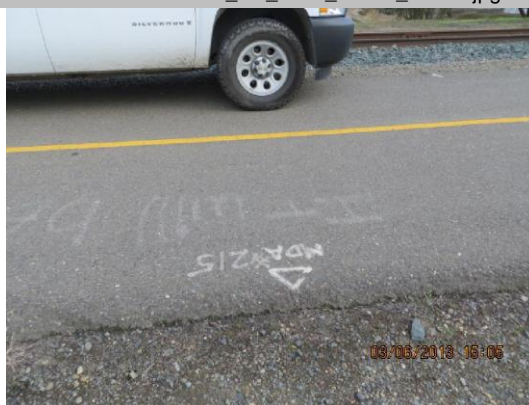
Photo 3 of 3 : UCIP_SP_2017_32883_59500.jpg

View of levee crown (trail) near waterward shoulder edge.

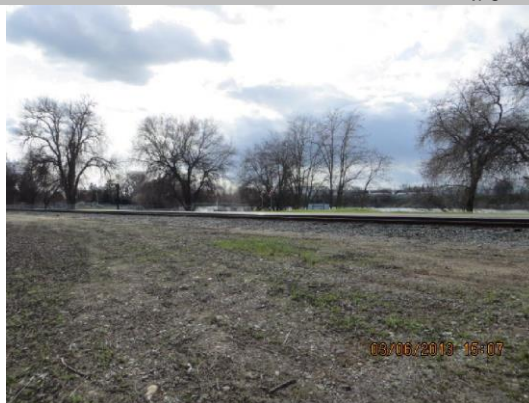
Photo 2 of 3 : UCIP_SP_2017_41442_59559.jpg

View of crossing approximately 110 feet downstream--large sign located on waterward slope.

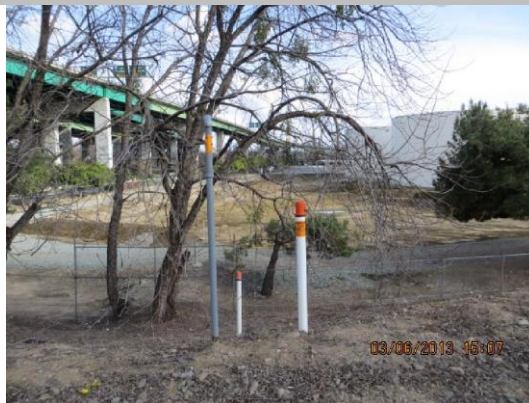
Photo 3 of 3 : UCIP_SP_2017_41442_59558.jpg

View of stand pipes located on landward side.

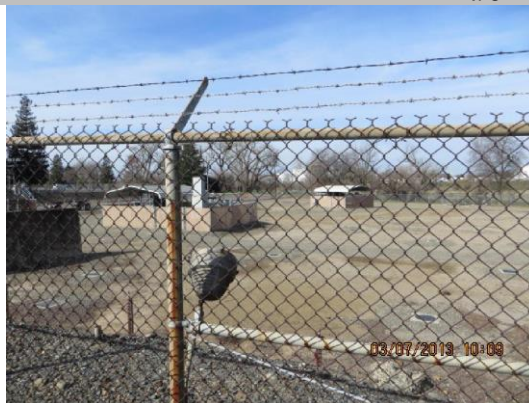
Photo 1 of 3 : UCIP_SP_2017_41282_59575.jpg

Comment Code					
Inspector Comment					
FS_ID:41282 DS_ID:21604 EP_NO: 18009 Repair Type: Non-Urgent Crossing Status: Found UCIP Comments: Project has reached 5 years is this project still in use? Permit issued for abandonment of treatment? Assumed installation date of 7/1/2005 per inspector's notes indicating work was completed in the summer of 2005. FIELD_STRUCT_DESC: Ozone Injection and Soil Vapor Extraction Treatment System for Former Tosco Bulk Fuel Terminal #3493. To authorize and retain (for approximately 5 years) twenty-three 2 to 4-inch-diameter extraction wells and thirty-six 2-inch-diameter ozone wells; to excavate approximately 2,050 linear-feet of trench and install required PVC piping and electrical conduits from the wells to main and sub-compounds with necessary equipment to complete an ozone injection and soil vapor extraction treatment system on the overflow area of the left (east) bank levee of the Sacramento River. FS Date: 3/7/2013

Structures present inside lot--site of Ozone Injection and Soil Vapor Extration System for the former Tosco Bulk Fuel.

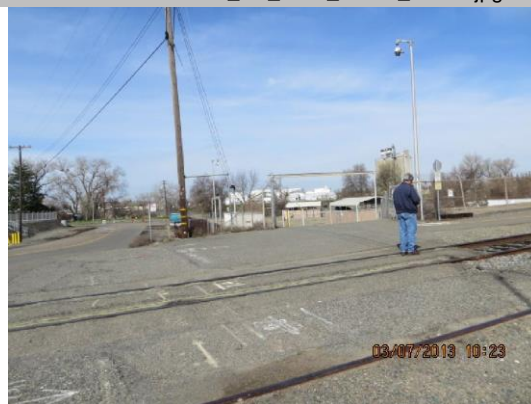
Photo 1 of 3 : UCIP_SP_2017_41427_59507.jpg

LM Start	1.74	Rating **	M	Issue No.	144
LM End	1.74	Issue Type +	En	Location *	WS
Category	Supplemental		GPS Latitude/Longitude		
			Start	End	
Item	DWR UCIP Field Study		38.567981 °	38.567981 °	
			-121.516077 °	-121.516077 °	
DWR ID					
Comment Code					
Inspector Comment					
FS_ID:41427 DS_ID:21575 EP_NO: 9259 Repair Type: Non-Urgent Crossing Status: Indicator Found UCIP Comments: Backflow device next to fence area angled--unable to confirm if device is part of crossing appurtenances. FIELD_STRUCT_DESC: 12-inch cast iron water main pipe sleeved through a 20-inch steel casing 3.0 feet below the crown elevation. (Permit No. 9259, City of Sacramento-1974) FS Date: 3/7/2013

View of wide levee crown--old railroad tracks, former Tosco Bulk Fuel Terminal #3493, utility poles, and fire hydrant.

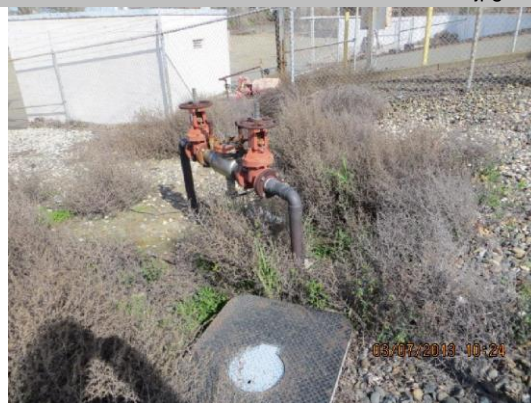
Photo 3 of 3 : UCIP_SP_2017_41427_59505.jpg

Close up of positive closure device.

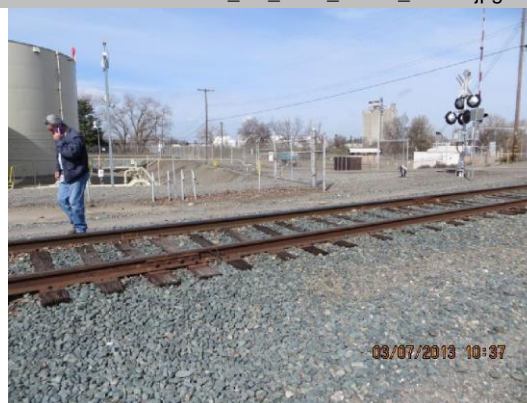
Photo 3 of 3 : UCIP_SP_2017_41452_59523.jpg

Pipe markers visible along chain link fence on waterward side.

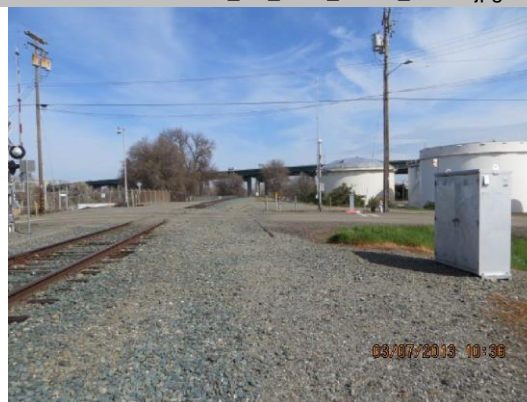
Photo 1 of 3 : UCIP_SP_2017_41448_59511.jpg

Comment Code					
Inspector Comment					
FS_ID:41448					
DS_ID:22383					
EP_NO: 8816					
Repair Type: Non-Urgent					
Crossing Status: Found					
UCIP Comments: High rodent on landward side. Dense vegetation limits the inspector's visibility to identify signs of pipe failure (leaks) through the slope. Recommend removing vegetation along pipe alignment to conduct proper inspection of structure and appurtenances.					
FIELD_STRUCT_DESC: 2 of 4: 10 inch line (premium) encased in 16 inch casing approximately 4 feet below crown. Vent pipes installed at each end of the conductor pipe. (Permit No. 8816, Phillips Petroleum Company-1974)					
FS Date: 3/7/2013

View of levee crown looking upstream--rail road traffic signal box located on right side.

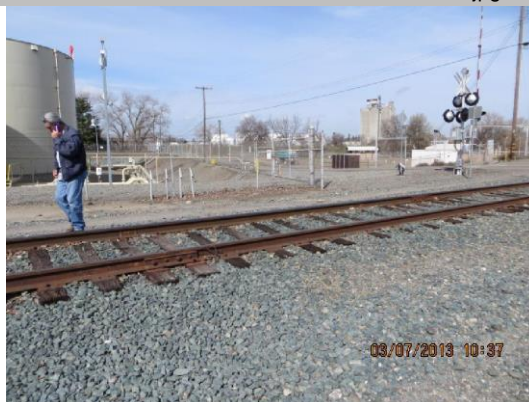
Photo 2 of 3 : UCIP_SP_2017_41449_59517.jpg

View of waterward side--markers visible along chain link fence.

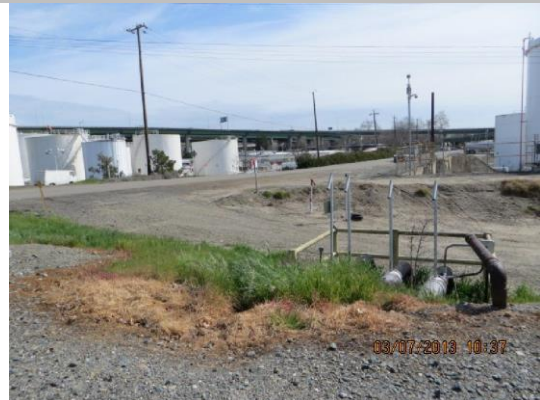
Photo 1 of 3 : UCIP_SP_2017_48322_59521.jpg

Comment Code					
Inspector Comment					
FS_ID:48322 DS_ID:22385 EP_NO: 8816 Repair Type: Non-Urgent Crossing Status: Found UCIP Comments: *5th pipe present (mystery pipe) 38.567748966, -121.516011521 not listed in permit* High rodent on landward side. Dense vegetation limits the inspector's visibility to identify signs of pipe failure (leaks) through the slope. Recommend removing vegetation along pipe alignment to conduct proper inspection of structure and appurtenances. FIELD_STRUCT_DESC: 4 of 4: 10 inch line (diesel) encased in 16 inch casing approximately 4 feet below crown. Vent pipes installed at each end of the conductor pipe. (Permit No. 8816, Phillips Petroleum Company-1974) FS Date: 3/7/2013

View multiple crossings visible on landward side.

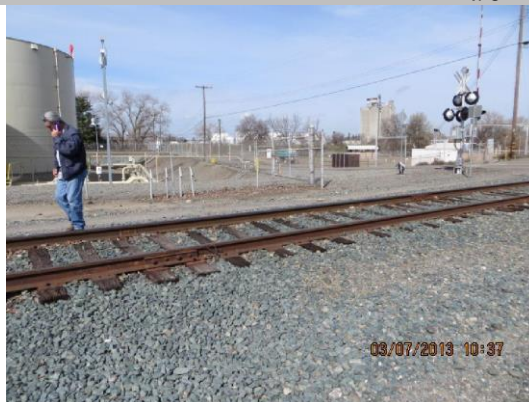
Photo 3 of 3 : UCIP_SP_2017_48322_59519.jpg

Pipe markers visible along the chain link fence on waterward side.

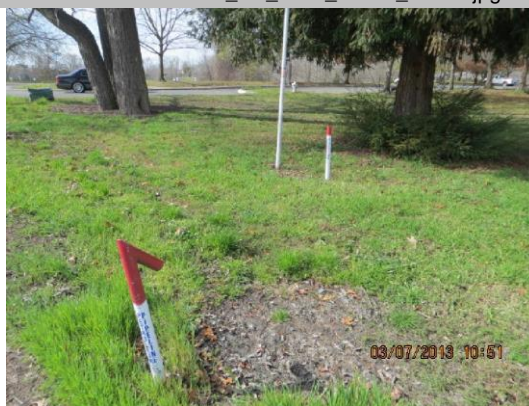
Photo 1 of 3 : UCIP_SP_2017_41457_59529.jpg

LM Start	1.78	Rating **	M	Issue No.	149
LM End	1.78	Issue Type +	En	Location *	WS
Category	Supplemental			GPS Latitude/Longitude	
				Start	End
Item	DWR UCIP Field Study			38.567352 °	38.567352 °
				-121.516102 °	-121.516102 °
DWR ID					
Comment Code					
Inspector Comment					
FS_ID:41457 DS_ID:21576 EP_NO: 4914 Repair Type: Non-Urgent Crossing Status: Indicator Found UCIP Comments: Need records confirming crossing is free of leaks. FIELD_STRUCT_DESC: 8-inch pipe through the levee, 5.0 feet below the crown and along the waterward side to Levee Mile 2.41, for river crossing under the channel. (Permit No. 4914, A, B, C-Standard Oil Co.) FS Date: 3/7/2013

View of waterward side--markers visible through levee.

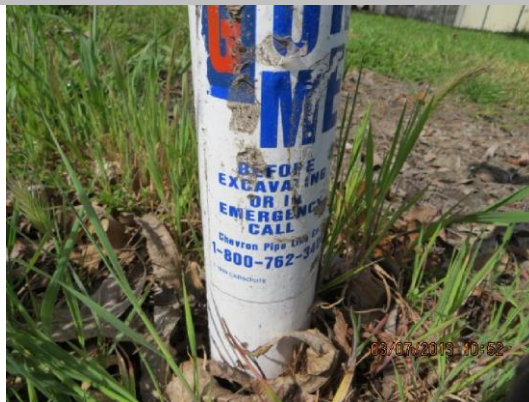
Photo 2 of 3 : UCIP_SP_2017_41457_59528.jpg

Contact information before excavation or in case of emergency.

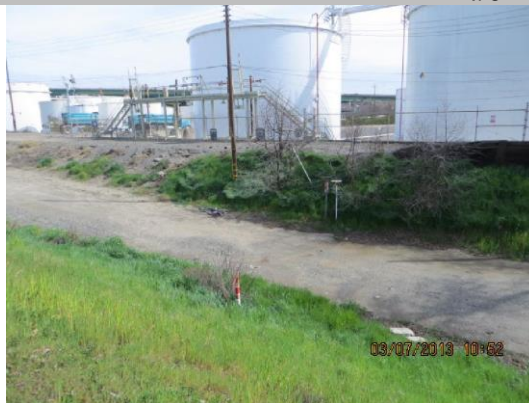
Photo 3 of 3 : UCIP_SP_2017_41457_59527.jpg

Markers visible on landward side.

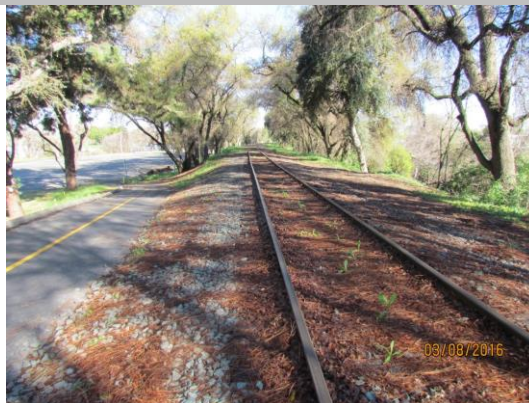
Photo 4 of 4 : SP_2017_NA0005_251_7_20170320_00007.jpg

View of the railroad tracks at levee mile 2.34 on the crown of the levee looking upstream. Spring 2016.

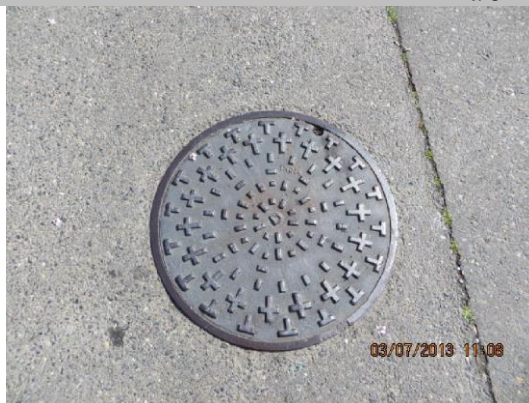
Photo 1 of 3 : UCIP_SP_2017_41430_72757.jpg

LM Start	1.96	Rating **	M	Issue No.	151
LM End	1.96	Issue Type +	En	Location *	CR
Category	Supplemental			GPS Latitude/Longitude	
				Start	End
Item	DWR UCIP Field Study			38.564843 °	38.564843 °
				-121.516246 °	-121.516246 °
DWR ID					
Comment Code					
Inspector Comment					
FS_ID:41430 DS_ID:21613 EP_NO: 7434 Repair Type: Non-Urgent Crossing Status: Indicator Found UCIP Comments: 2 manholes and sump pump present. Need to update description to confirm if this permit is for Sump-3. FIELD_STRUCT_DESC: 4 inch sanitary sewer force main 3/8" steel with 1/8" mortar liner and ashalt coated on the outside. Line runs along the center of the levee for approximately 1700 feet. (Permit No. 7434, City of Sacramento-1972) FS Date: 3/7/2013

Manhole present on roadway.

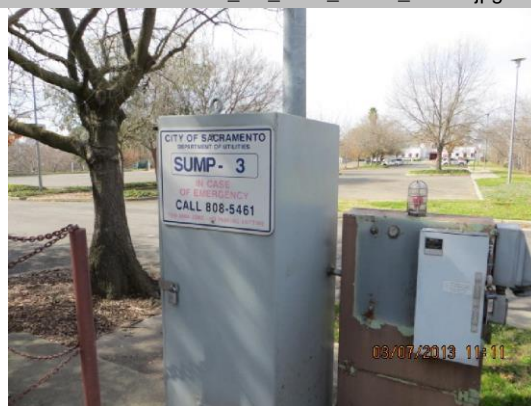
Photo 2 of 3 : UCIP_SP_2017_41430_72756.jpg

LM Start	1.96	Rating **	M	Issue No.	151 (cont)
LM End	1.96	Issue Type +	En	Location *	CR
Category	Supplemental	GPS Latitude/Longitude			
		Start	End		
Item	DWR UCIP Field Study	38.564843 °	38.564843 °		
		-121.516246 °	-121.516246 °		
DWR ID					
Comment Code					
Inspector Comment					
FS_ID:41430 DS_ID:21613 EP_NO: 7434 Repair Type: Non-Urgent Crossing Status: Indicator Found UCIP Comments: 2 manholes and sump pump present. Need to update description to confirm if this permit is for Sump-3. FIELD_STRUCT_DESC: 4 inch sanitary sewer force main 3/8" steel with 1/8" mortar liner and ashalt coated on the outside. Line runs along the center of the levee for approximately 1700 feet. (Permit No. 7434, City of Sacramento-1972) FS Date: 3/7/2013

Sump pump station 3.

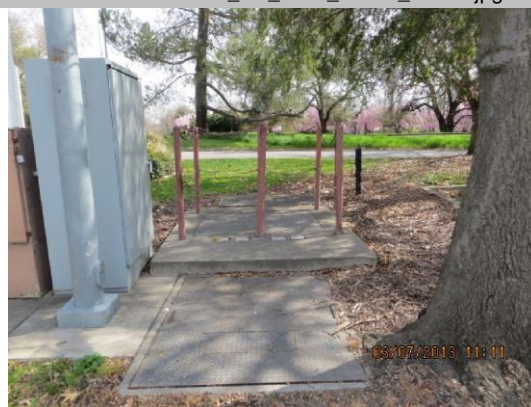
Photo 3 of 3 : UCIP_SP_2017_41430_72755.jpg

Service vault visible on levee crown.

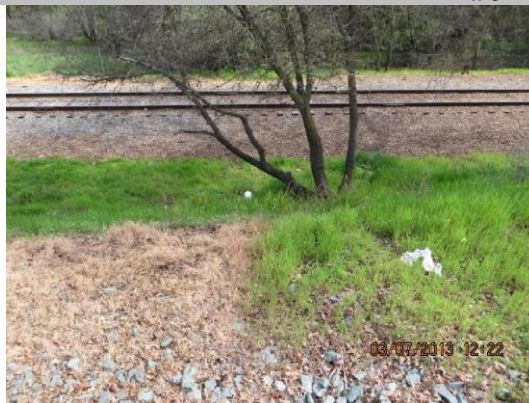
Photo 1 of 2 : UCIP_SP_2017_41293_72760.jpg

LM Start	2.04	Rating **	M	Issue No.	156
LM End	2.04	Issue Type +	En	Location *	CR
Category	Supplemental			GPS Latitude/Longitude	
				Start	End
Item	DWR UCIP Field Study			38.563702 °	38.563702 °
				-121.515876 °	-121.515876 °
DWR ID					
Comment Code					
Inspector Comment					
FS_ID:41293 DS_ID:24921 EP_NO: N/A Repair Type: Non-Urgent Crossing Status: Indicator Found UCIP Comments: Need to contact owner to determine type of crossing and status. Need to find out the alignment of crossing. FIELD_STRUCT_DESC: 1 of 4. Crossing found through railroad/levee visible on landward side. FS Date: 3/6/2013

PVC pipe through levee.

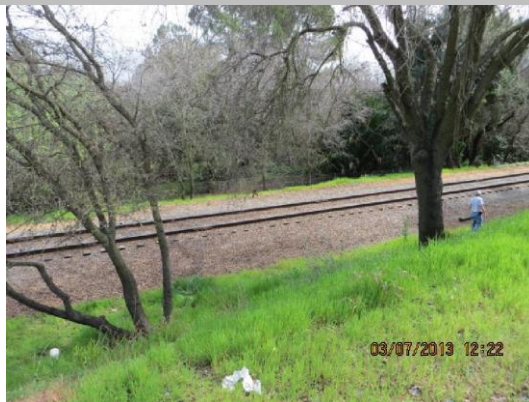
Photo 2 of 2 : UCIP_SP_2017_41293_72759.jpg

View of landward side.

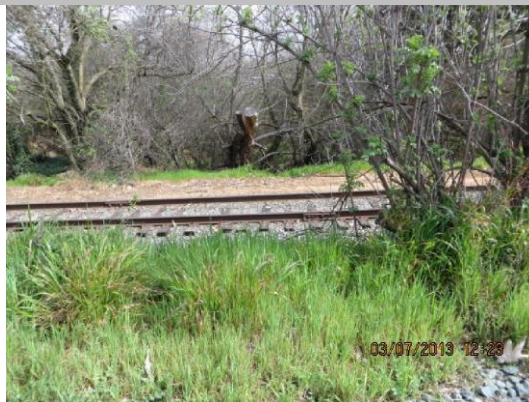
Photo 2 of 2 : UCIP_SP_2017_41295_72763.jpg

Dense vegetation along landward slope.

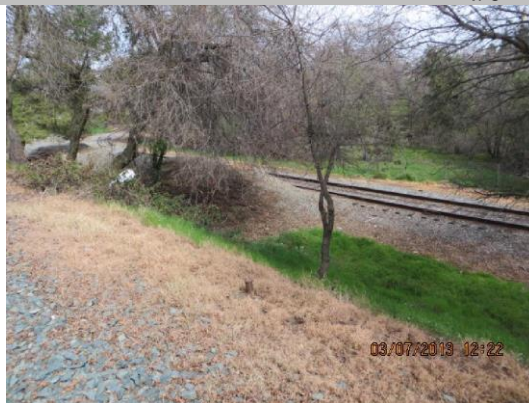
Photo 1 of 2 : UCIP_SP_2017_38827_72766.jpg

LM Start	2.12	Rating **	M	Issue No.	159
LM End	2.12	Issue Type +	En	Location *	CR
Category	Supplemental			GPS Latitude/Longitude	
				Start	End
Item	DWR UCIP Field Study			38.562532 °	38.562532 °
				-121.515763 °	-121.515763 °
DWR ID					
Comment Code					
Inspector Comment					
FS_ID:38827 DS_ID:24924 EP_NO: N/A Repair Type: Non-Urgent Crossing Status: Indicator Found UCIP Comments: Need to contact owner to determine type of crossing and status. Need to find out the alignment of crossing. FIELD_STRUCT_DESC: 4 of 4. Crossing found through railroad/levee visible on landward side. FS Date: 3/6/2013

View of landward side.

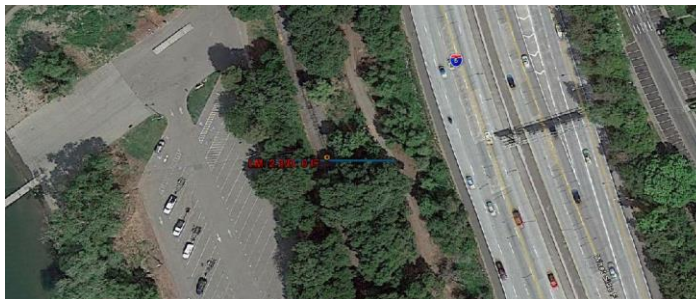
Photo 1 of 1 : UCIP_SP_2017_41431_72800.jpg

LM Start	2.29	Rating **	M	Issue No.	160
LM End	2.29	Issue Type +	En	Location *	WS
Category	Supplemental			GPS Latitude/Longitude	
				Start	End
Item	DWR UCIP Field Study			38.560088 °	38.560088 °
				-121.515150 °	-121.515150 °
DWR ID					
Comment Code					
Inspector Comment					
FS_ID:41431					
DS_ID:24925					
EP_NO: N/A					
Repair Type: Non-Urgent					
Crossing Status: Indicator Found					
UCIP Comments: Need to coordinate with owner to determine status of crossing.					
FIELD_STRUCT_DESC: 18 inch storm drain at unknown depth.					
Crossing information was obtained from Sacramento County GIS records. (Permit No. 1425, 1949)					
FS Date: 3/6/2013

Approximate alignment through levee provided by the City of Sacramento GIS.

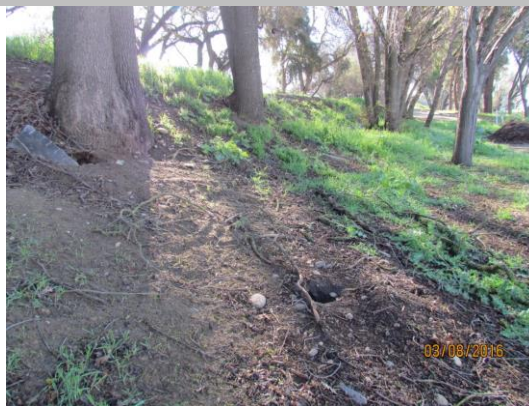
Photo 1 of 1 : SP_2017_NA0005_251_82_20170320_00018.jpg

LM Start	2.31	Rating **	M	Issue No.	82
LM End	2.31	Issue Type +	Ma	Location *	WS
Category	Earthen Levee			GPS Latitude/Longitude	
				Start	End
Item	Animal Control			38.559767 °	38.559767 °
				-121.515264 °	-121.515264 °
DWR ID	DWR_NA0005_01_s_2016_82				
Comment Code					
A3 : No rodents visible, but rodent burrows visible; need to backfill and compact or grout burrows.					
Inspector Comment

View of the rodent holes on the waterward side of the levee looking downstream. Spring 2016.

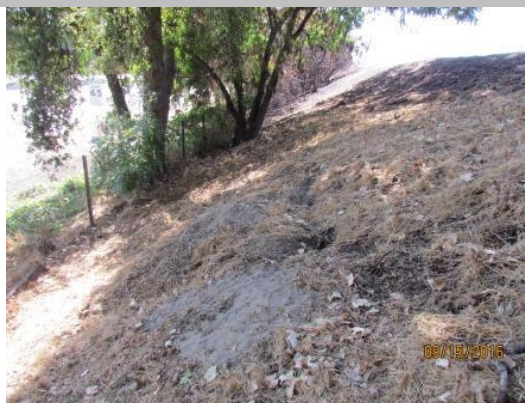
Photo 1 of 1 : SP_2017_NA0005_251_78_20170320_00017.jpg

LM Start	2.43	Rating **	U	Issue No.	78
LM End	2.43	Issue Type +	Ma	Location *	LS
Category	Earthen Levee			GPS Latitude/Longitude	
				Start	End
Item	Animal Control			38.558281 °	38.558281 °
				-121.514393 °	-121.514393 °
DWR ID	DWR_NA0005_01_f_2015_78				
Comment Code					
A1 : Exterminate rodents and backfill and compact or grout burrows.					
Inspector Comment

Rodent holes with more than 2 cub ft. of soil taken out found on landside slope of the levee. Fall 2016.

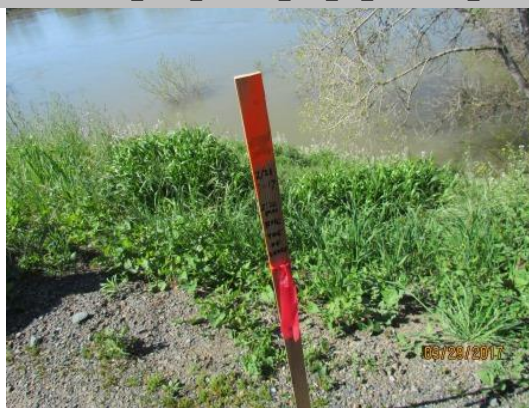
Photo 1 of 1 : SP_2017_NA0005_251_95_20170414_00148.jpg

LM Start	2.45	Rating **	A/W	Issue No.	95
LM End	2.45	Issue Type +	Ma	Location *	WS
Category	Earthen Levee			GPS Latitude/Longitude	
				Start	End
Item	Erosion / Bank Caving			38.557890 °	38.557890 °
				-121.514249 °	-121.514249 °
DWR ID	DWR_NA0005_01_s _ 2017_95				
Comment Code					
E1 : Note and monitor erosion site.					
Inspector Comment					
Erosion on waterside levee toe staked during February high water event.

Erosion on waterside levee toe staked during February high water event.
The erosion appears to be underwater. Spring 2017.

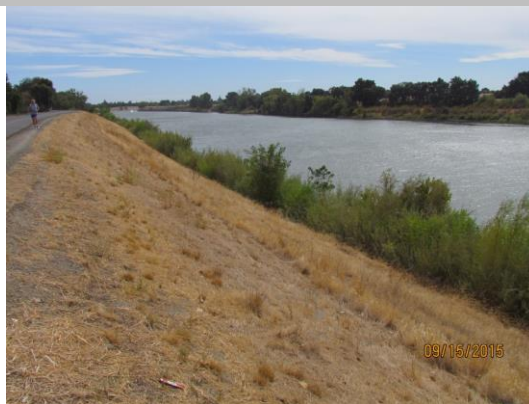
Photo 1 of 2 : SP_2017_NA0005_251_21_20170320_00012.jpg

LM Start	2.46	Rating **	A/W	Issue No.	21
LM End	2.75	Issue Type +	Ob	Location *	WS
Category	Earthen Levee			GPS Latitude/Longitude	
				Start	End
Item	Vegetation			38.557828 °	38.553710 °
				-121.514193 °	-121.512863 °
DWR ID	DWR_NA0005_01_s _ 2012_21				
Comment Code					
V8 : Environmental Requirements.					
Inspector Comment					
Revegetation site is at the toe of the levee on the waterward side.

View of the revegetation site on the waterward side looking downstream.
Fall 2015.

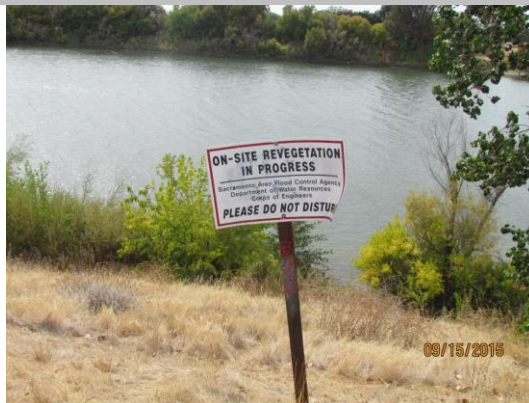
Photo 2 of 2 : SP_2017_NA0005_251_21_20170320_00013.jpg

LM Start	2.46	Rating **	A/W	Issue No.	21 (cont)	
LM End	2.75	Issue Type +	Ob	Location *	WS	
Category	Earthen Levee			GPS Latitude/Longitude		
				Start		End
Item	Vegetation			38.557828 °		38.553710 °
				-121.514193 °		-121.512863 °
DWR ID	DWR_NA0005_01_s_2012_21					
Comment Code						
V8 : Environmental Requirements.						
Inspector Comment						
Revegetation site is at the toe of the levee on the waterward side.

This area is a revegetation site. Fall 2015.

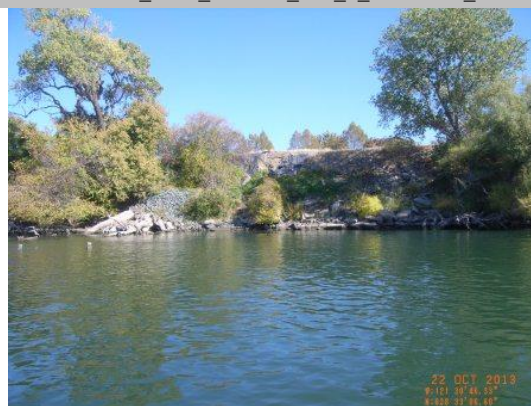
Photo 1 of 1 : SP_2017_NA0005_251_2_20170320_00003.jpg

LM Start	2.85	Rating **	M	Issue No.	2
LM End	3.67	Issue Type +	Ma	Location *	WS
Category	Supplemental			GPS Latitude/Longitude	
				Start	End
Item	2015 USACE Erosion Survey, DRAFT			38.552268 °	38.541081 °
				-121.512590 °	-121.511480 °
DWR ID	DWR_NA0005_01_s _ 2016_2				
Comment Code					
Inspector Comment					
1997 - Erosion at pump station, concrete debris and plastic showing. 2000 - Separation scour of bank due to poor transition. 2004 - New large tree pop out; city dumped fill dirt/rock into hole. 2006 - Minor new erosion at top of bank. 2010 - Some new rock placed in tree pop-out. 2011 - A large tree has fallen and flood fighting was performed by the city on the upper levee slope. 2012 - Small rock placed in hole from tree popout. 2015: No observed changes. [2015 Site ID: SAC_56-6_L]

USACE 2013 Photo #1

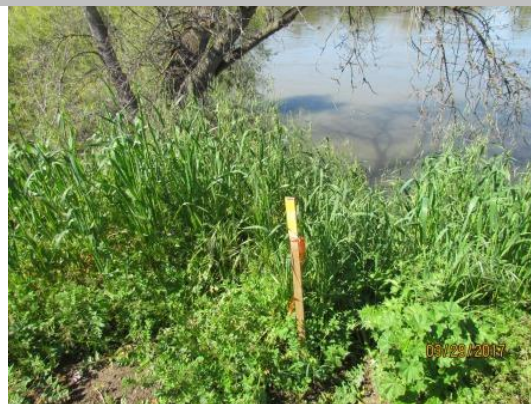
Photo 1 of 1 : SP_2017_NA0005_251_96_20170414_00149.jpg

LM Start	2.88	Rating **	A/W	Issue No.	96
LM End	2.88	Issue Type +	Ma	Location *	WS
Category	Earthen Levee			GPS Latitude/Longitude	
				Start	End
Item	Erosion / Bank Caving			38.551953 °	38.551953 °
				-121.511953 °	-121.511953 °
DWR ID	DWR_NA0005_01_s _ 2017_96				
Comment Code					
E1 : Note and monitor erosion site.					
Inspector Comment					
Sloughing on waterside levee slope.

Sloughing on waterside levee slope. Spring 2017.

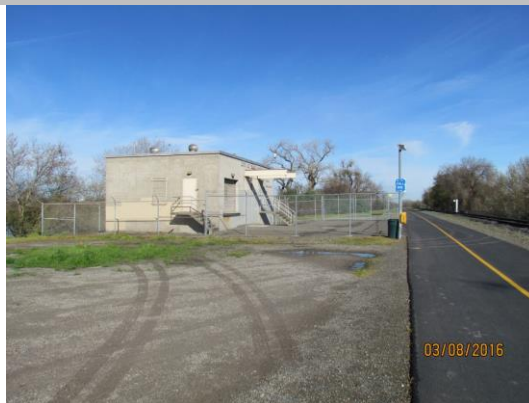
Photo 1 of 1 : SP_2017_NA0005_251_10_20170320_00009.jpg

LM Start	2.89	Rating **	M	Issue No.	10
LM End	2.89	Issue Type +	En	Location *	CR
Category	Earthen Levee			GPS Latitude/Longitude	
				Start	End
Item	Encroachments			38.551810 °	38.551810 °
				-121.511838 °	-121.511838 °
DWR ID	DWR_NA0005_01_s_2012_10				
Comment Code					
BU : Building					
Inspector Comment

View of the City of Sacramento pump station on the waterward side of the levee looking upstream. Spring 2016.

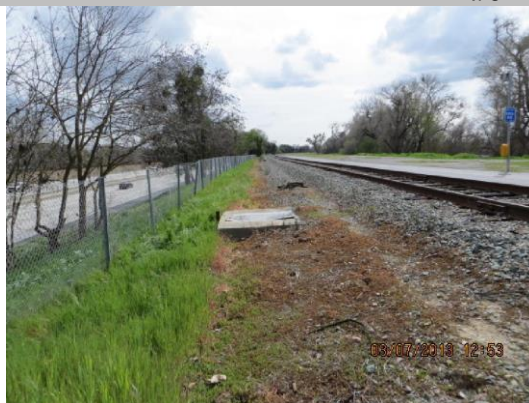
Photo 1 of 3 : UCIP_SP_2017_45133_59534.jpg

LM Start	2.89	Rating **	M	Issue No.	163
LM End	2.89	Issue Type +	En	Location *	CR
Category	Supplemental			GPS Latitude/Longitude	
				Start	End
Item	DWR UCIP Field Study			38.551797 °	38.551797 °
				-121.511859 °	-121.511859 °
DWR ID					
Comment Code					
Inspector Comment					
FS_ID:45133 DS_ID:21578 EP_NO: 2043 Repair Type: Non-Urgent Crossing Status: Found UCIP Comments: This crossing has been abandoned. According to City of Sacramento Staff the last time this crossing was fired up to see if it was functioning was 3 years ago. Recommend owner coordinating with Central Valley Flood Protection Board (CVFPB) to abandon facility per Title 23. FIELD_STRUCT_DESC: Ranney collector on waterward slope. Ranney collector with 24 inch discharge pipe through levee. (Permit No. 2043, City of Sacramento-1955). FS Date: 3/7/2013

Concrete vault located on landward shoulder.

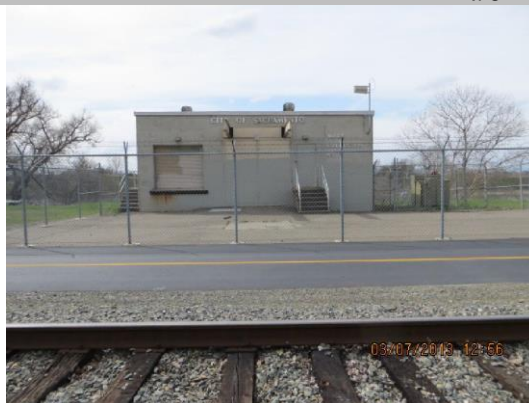
Photo 2 of 3 : UCIP_SP_2017_45133_59532.jpg

Ranney collector facility operated by the City of Sacramento.

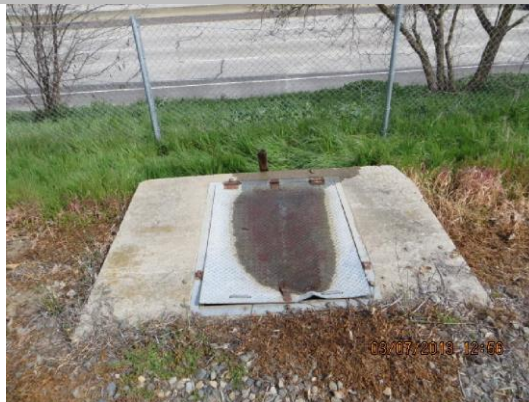
Photo 3 of 3 : UCIP_SP_2017_45133_59531.jpg

Close up view of vault located on landward levee shoulder.

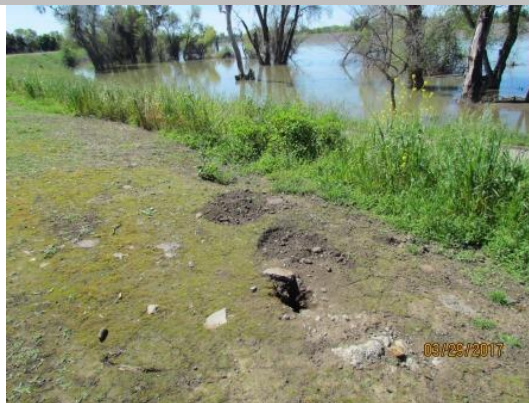
Photo 1 of 1 : SP_2017_NA0005_251_99_20170414_00150.jpg

LM Start	3.06	Rating **	M	Issue No.	99
LM End	3.06	Issue Type +	Ma	Location *	WS
Category	Earthen Levee			GPS Latitude/Longitude	
				Start	End
Item	Animal Control			38.549504 °	38.549504 °
				-121.511019 °	-121.511019 °
DWR ID	DWR_NA0005_01_s_2017_99				
Comment Code					
A1 : Exterminate rodents and backfill and compact or grout burrows.					
Inspector Comment					
Burrows on waterside levee slope

Burrows on waterside levee slope, looking towards Sacramento River.
Spring 2017.

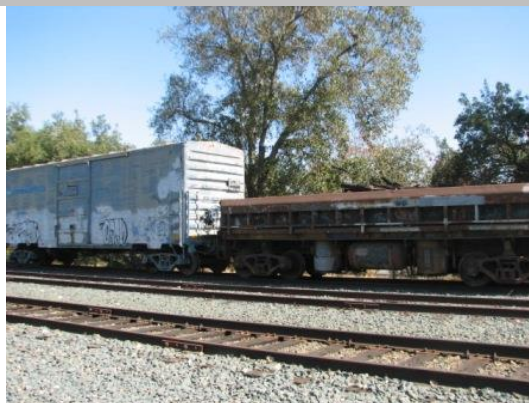
Photo 1 of 1 : SP_2017_NA0005_251_9_20170320_00008.jpg

LM Start	3.29	Rating **	M	Issue No.	9
LM End	3.29	Issue Type +	En	Location *	CR
Category	Earthen Levee			GPS Latitude/Longitude	
				Start	End
Item	Encroachments			38.546302 °	38.546302 °
				-121.510197 °	-121.510197 °
DWR ID	DWR_NA0005_01_f_2013_9				
Comment Code					
EQ : Equipment					
Inspector Comment					
There are four cars on the levee crown.

Trains cars are stored on the crown of the levee. Fall 2013

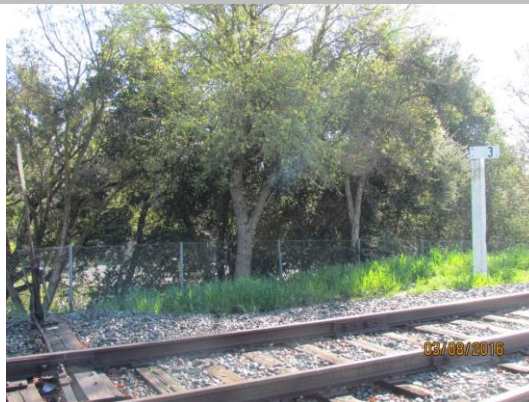
Photo 1 of 2 : SP_2017_NA0005_251_85_20170320_00020.jpg

LM Start	3.35	Rating **	M	Issue No.	85
LM End	3.35	Issue Type +	Ma	Location *	LS
Category	Earthen Levee			GPS Latitude/Longitude	
				Start	End
Item	Trim / Thin Trees			38.545403 °	38.545403 °
				-121.509830 °	-121.509830 °
DWR ID	DWR_NA0005_01_s_2016_85				
Comment Code					
T3 : Trim and thin trees to allow visibility of the ground and room to flood fight.					
Inspector Comment

View of the trees on the landward side of the levee. Spring 2016.

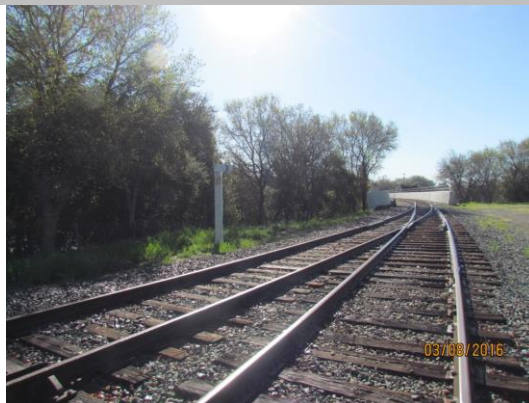
Photo 2 of 2 : SP_2017_NA0005_251_85_20170320_00021.jpg

LM Start	3.35	Rating **	M	Issue No.	85 (cont)	
LM End	3.35	Issue Type +	Ma	Location *	LS	
Category	Earthen Levee			GPS Latitude/Longitude		
				Start		End
Item	Trim / Thin Trees			38.545403 °		38.545403 °
				-121.509830 °		-121.509830 °
DWR ID	DWR_NA0005_01_s_2016_85					
Comment Code						
T3 : Trim and thin trees to allow visibility of the ground and room to flood fight.						
Inspector Comment

Perspective view of the trees on the landward side of the levee looking downstream. Spring 2016.
